Manhole Inspection Summary

Manhole # S21GG_018MH

Insp Date: **6/19/07 12:40 PM**

Location Address: **1600 BAKER ST**

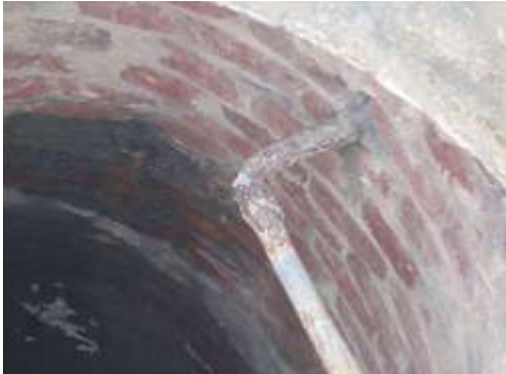
Defect 4

Count: **5** Missing: **0** ☒ **Corroded**

CORRODED STEPS

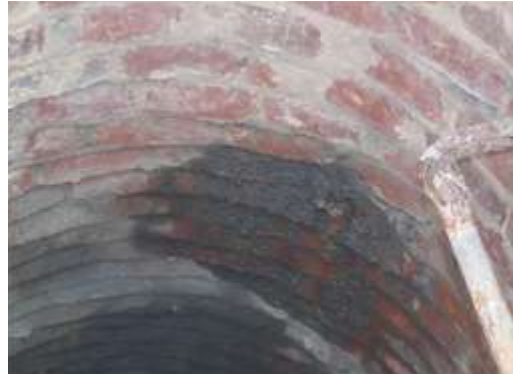
Defect 3

Infiltration: ☐ None ☐ Joint ☐ Cracks ☐ Mortar ☐ Roots ☒ **Wall**

INFILTRATION OF CORBEL

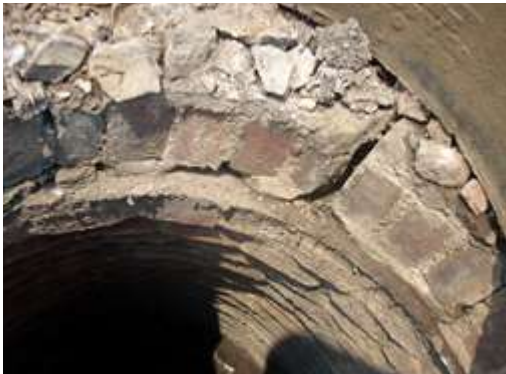
Defect 2

Condition: ☐ Sound ☐ Cracked ☐ Root Intrusion ☐ Loose Brick ☒ **Deteriorated**

DETERIORATION OF CHIMNEY

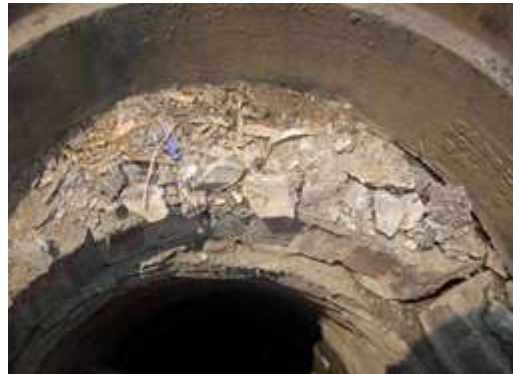
Defect 1

Offset: **8** (in.)

FRAME OFFSET

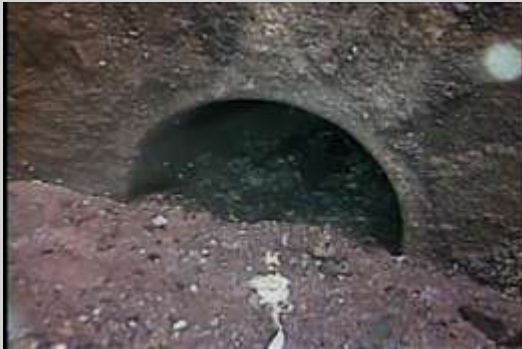
12 O'Clock Outflow

8 in. Circular Gravity Sewer
Pipe Out @ 12 O'Clock

Deposits: ☐ None ☒ **Mud** ☐ Sludge ☐ Debris ☐ Grease

Silt Depth: **3** (in.) Deposits Extent: **Medium**
